U.S. AIR FORCE
INSTALLATION RESTORATION PROGRAM .
PHASE I: RECORDS SEARCH

AIR NATIONAL GUARD, CAMP EDWARDS (ARNG),
U.S. AIR FORCE AND VETERAN'S ADMINISTRATION
FACILITIES AT MASSACHUSETTS MILITARY
RESERVATION, MASSACHUSETTS

FINAL REPORT: TASK 6

DECEMBER 11, 1986

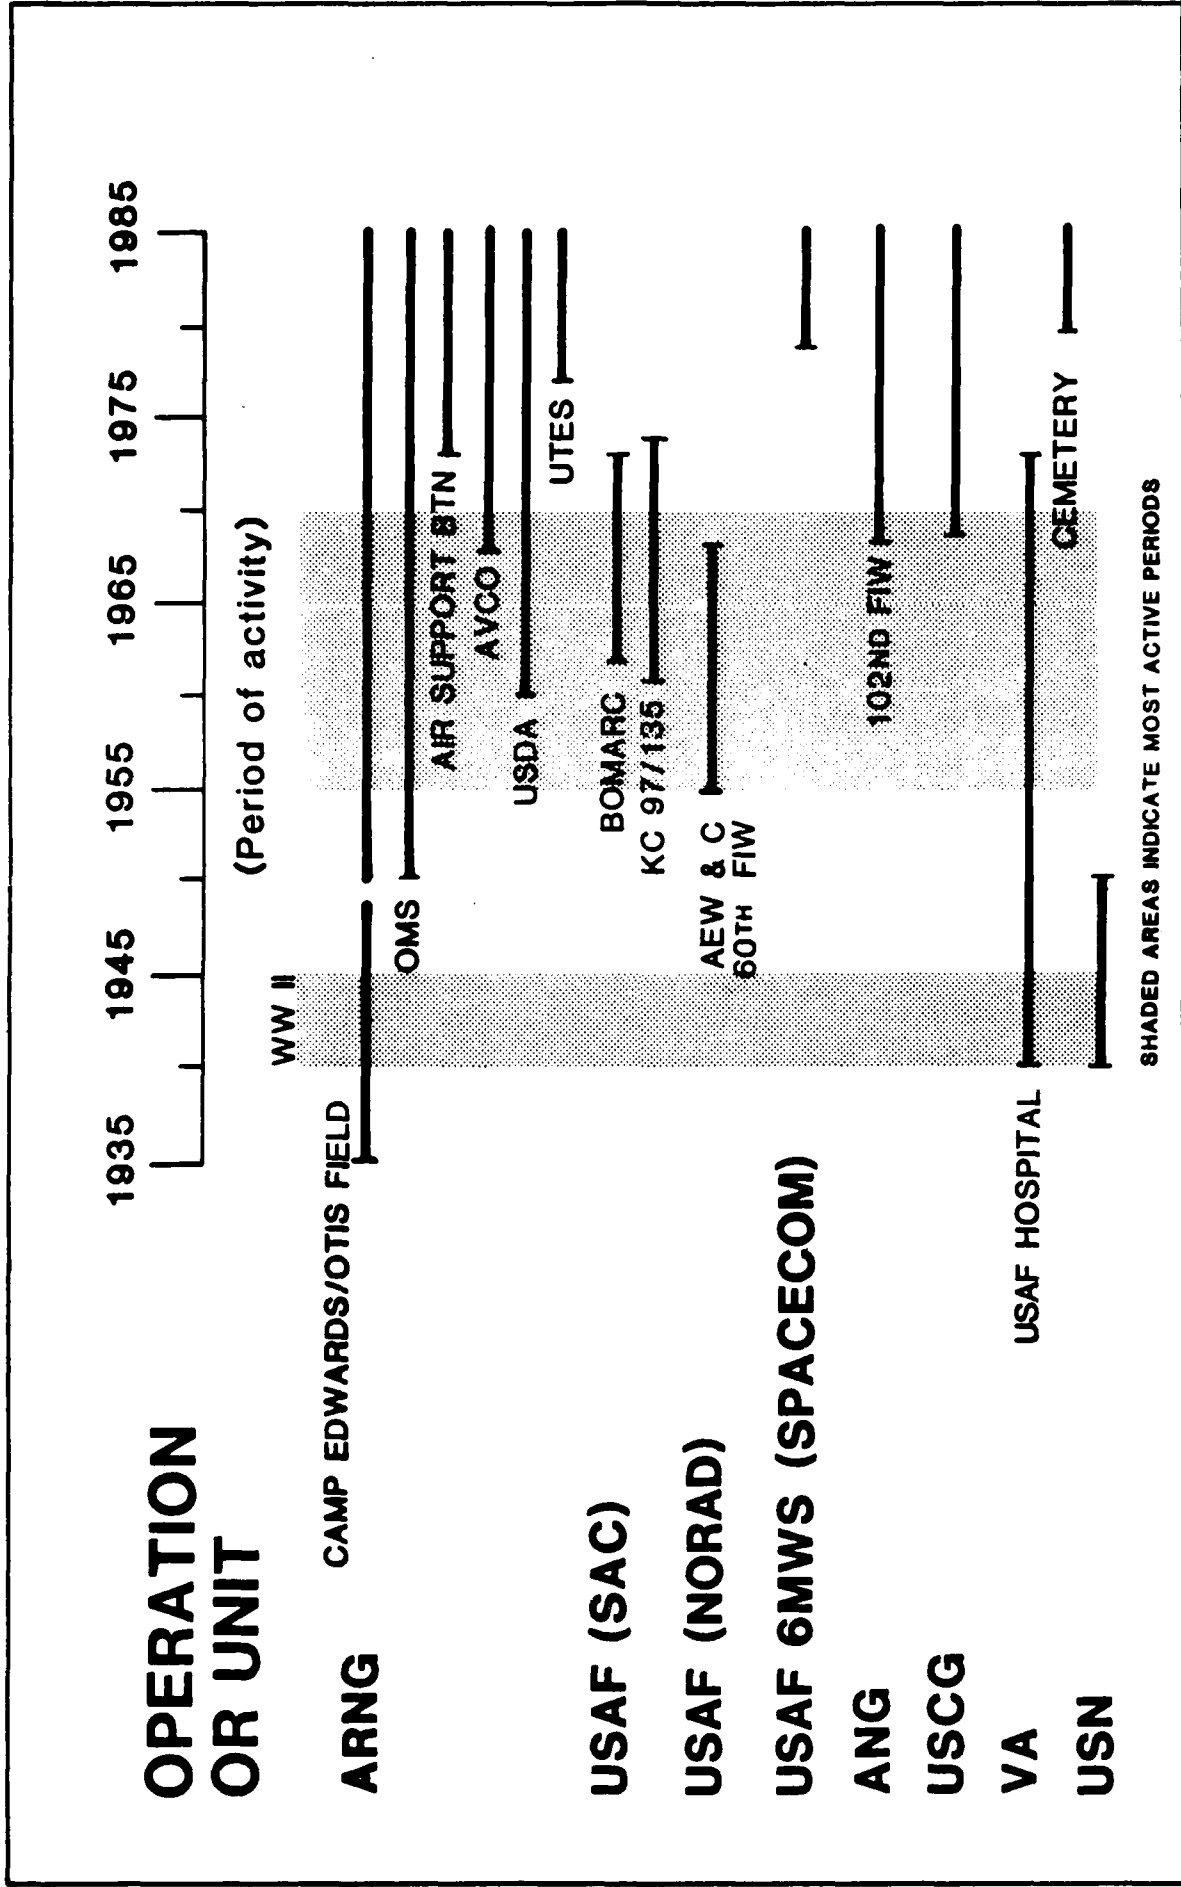
GENERALIZED CHRONOLOGY OF OPERATIONS AT MAAB	
ECJORDANCO [®] CONSULTING ENGINEERS	TASK 6
INSTALLATION RESTORATION PROGRAM MASSACHUSETTS MILITARY RESERVATION	FIGURE 2.2-1

Figure 2.2-1 shows an overview of the operational history for the major units and activities at MMR from 1935 to the present. Current missions and organization for MMR are outlined in Section 2.3.

USCG operations are the subject of a separate Phase I report prepared under the MMR IRP and will not be discussed in detail. However, the USCG timeline is shown in Figure 2.2-1 for comparison.

In general, two different types of operations have dominated military activity at MMR: 1) mechanized army training, maneuvers, and maintenance support and 2) military aircraft operations, maintenance, and support. The intensity and level of activity have varied over the MMR operational history. As shown in Figure 2.2-1, the most intensive army activity occurred during WWII (1940-1944) and during demobilization following the war. The most intensive aircraft operations occurred from 1955 to 1970 when large numbers of surveillance and

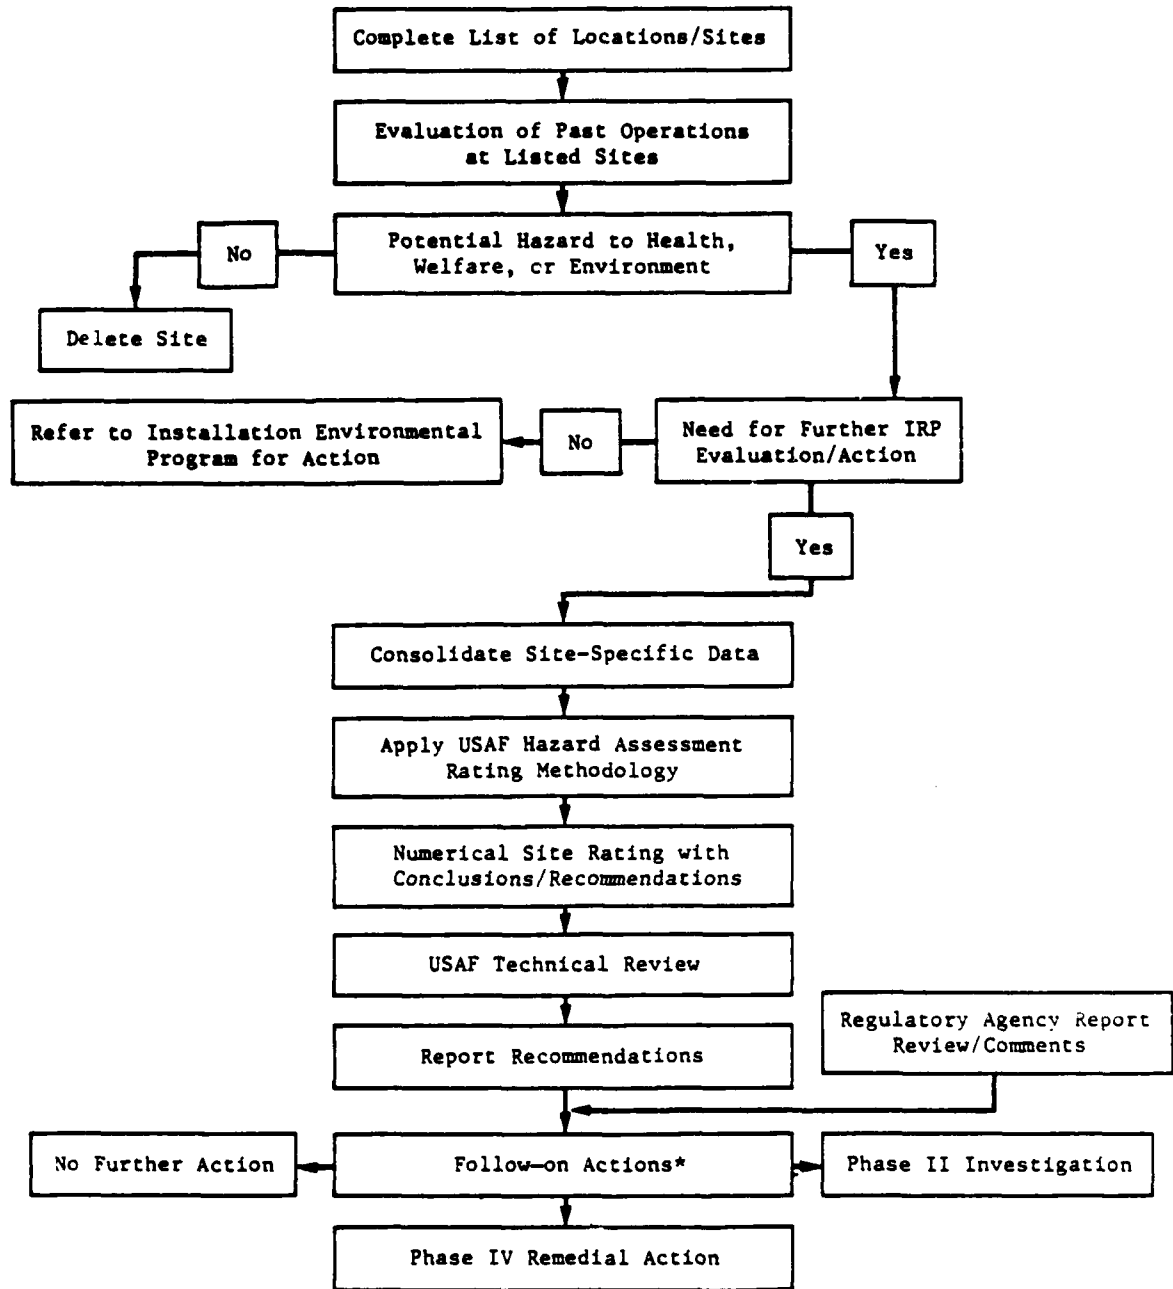
E.C. JORDAN CO. CONSULTING ENGINEERS	DECISION PROCESS	
INSTALLATION RESTORATION PROGRAM MASSACHUSETTS MILITARY RESERVATION	TASK 6	FIGURE 1.3-1

Using the process shown in Figure 1.3-1, a decision was then made, based on all of the previous information, regarding the potential for hazardous material contamination at any of the identified sites. If no potential contamination existed, the site was deleted from further consideration. If potential for contamination was identified, the potential for migration of the contaminant was assessed based on site-specific conditions. If no potential for migration existed and if there were no further environmental concerns, the site was deleted. If the potential for contaminant migration was considered significant, the site was evaluated and prioritized using the USAF Hazard Assessment Rating Methodology (HARM). A discussion of the HARM system is presented in Appendix G.

**PHASE I INSTALLATION RESTORATION PROGRAM
RECORDS SEARCH FLOWCHART**

* Refer to Figure 1.3-1 for the decision process.

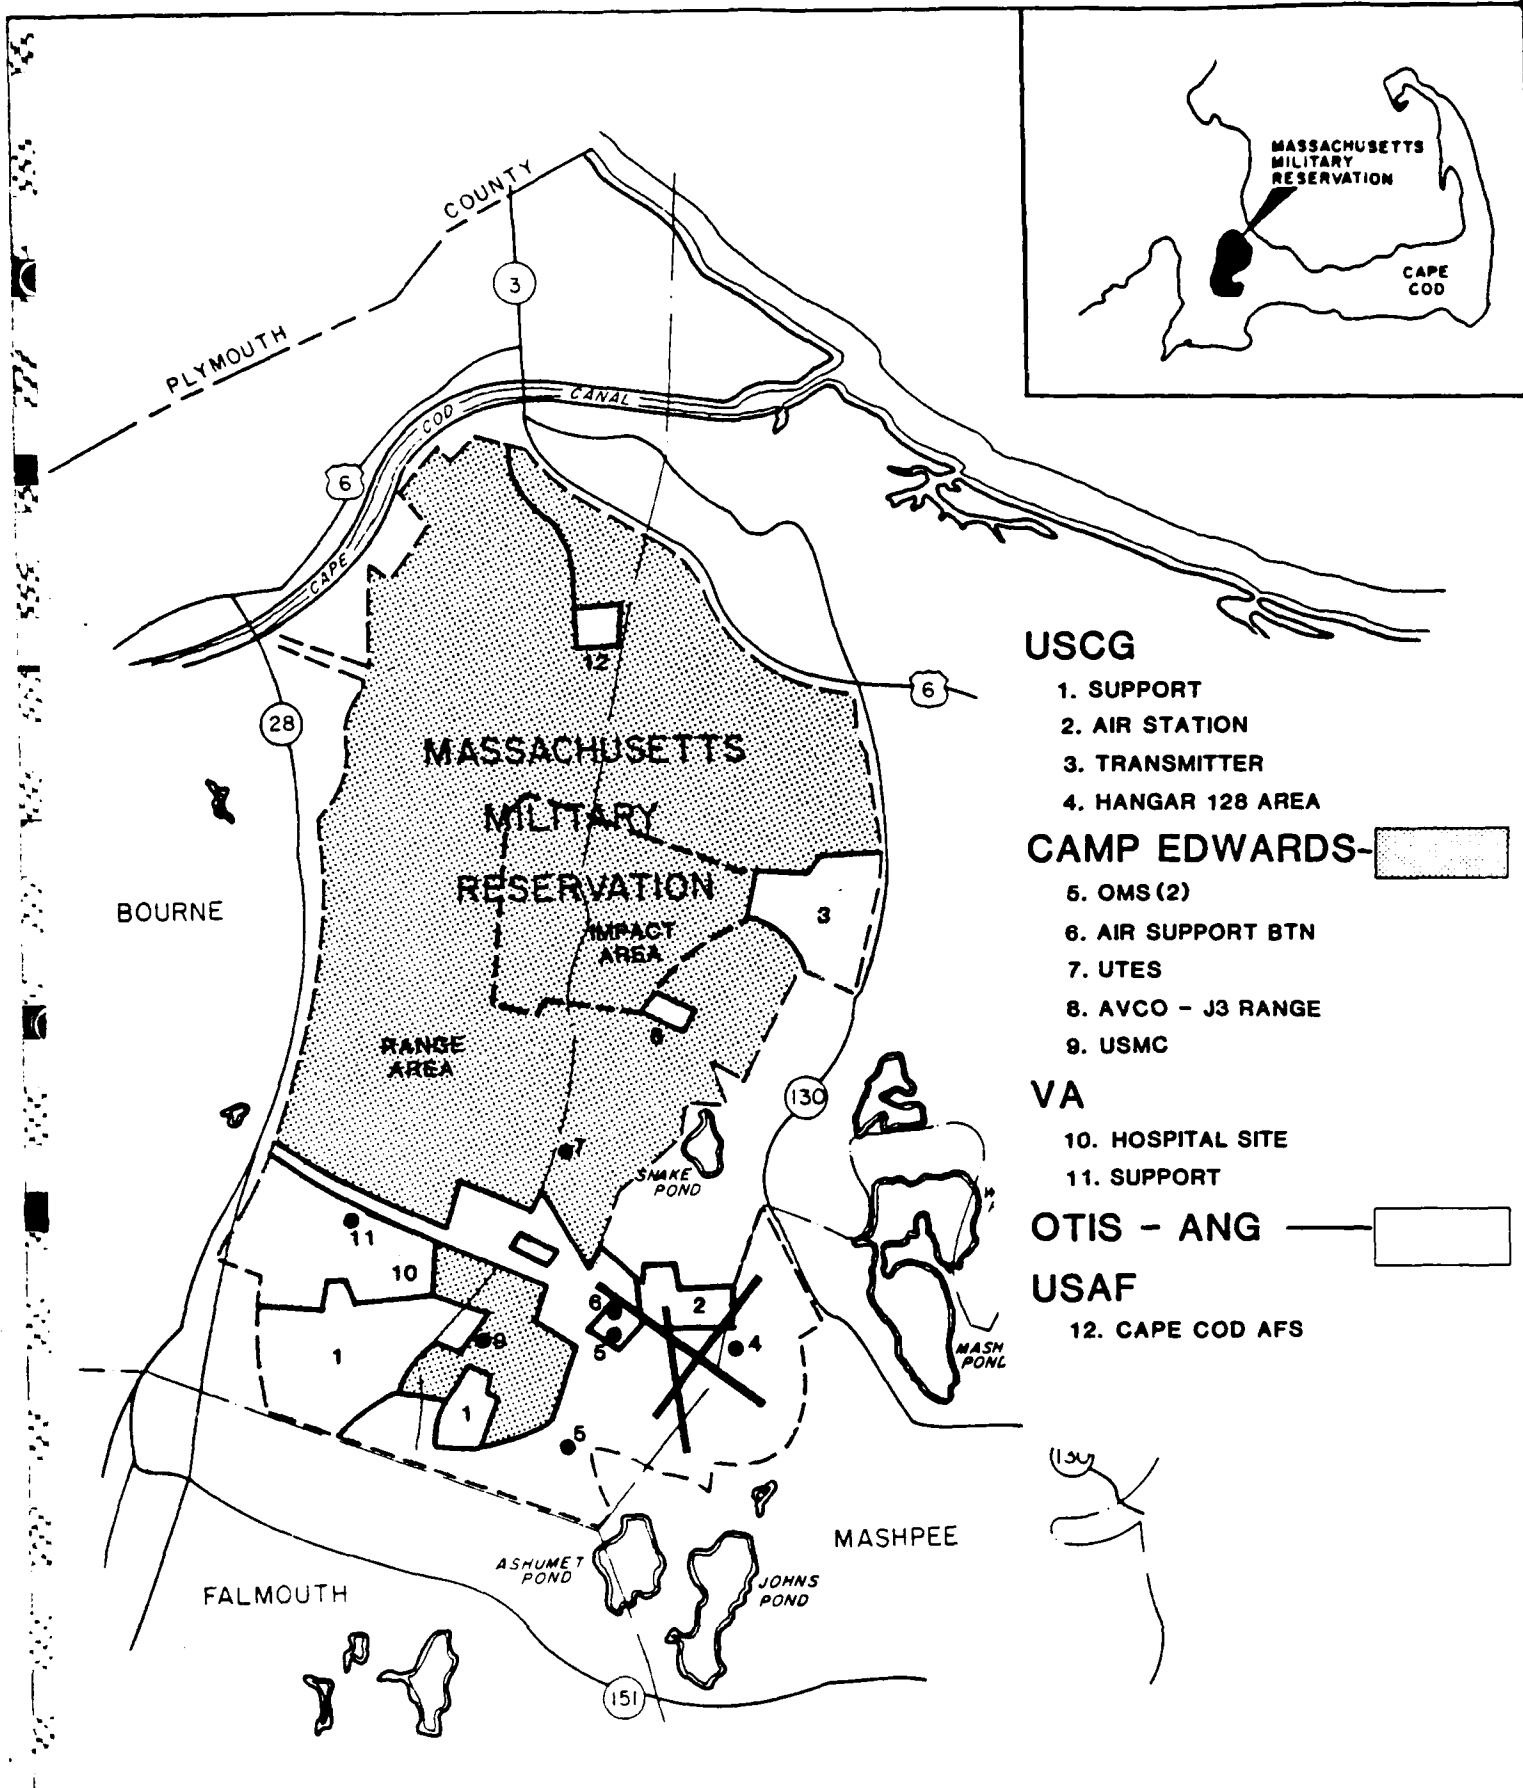
E.C. JORDAN CO. CONSULTING ENGINEERS		LOCATION OF MAJOR UNITS AT MM	
INSTALLATION RESTORATION PROGRAM MASSACHUSETTS MILITARY RESERVATION		TASK 6	FIGURE 2.1-

The locations that these units and their major tenants occupy on MMR are shown in Figure 2.1-2. The cooperative command structure is described in Section 2.3.

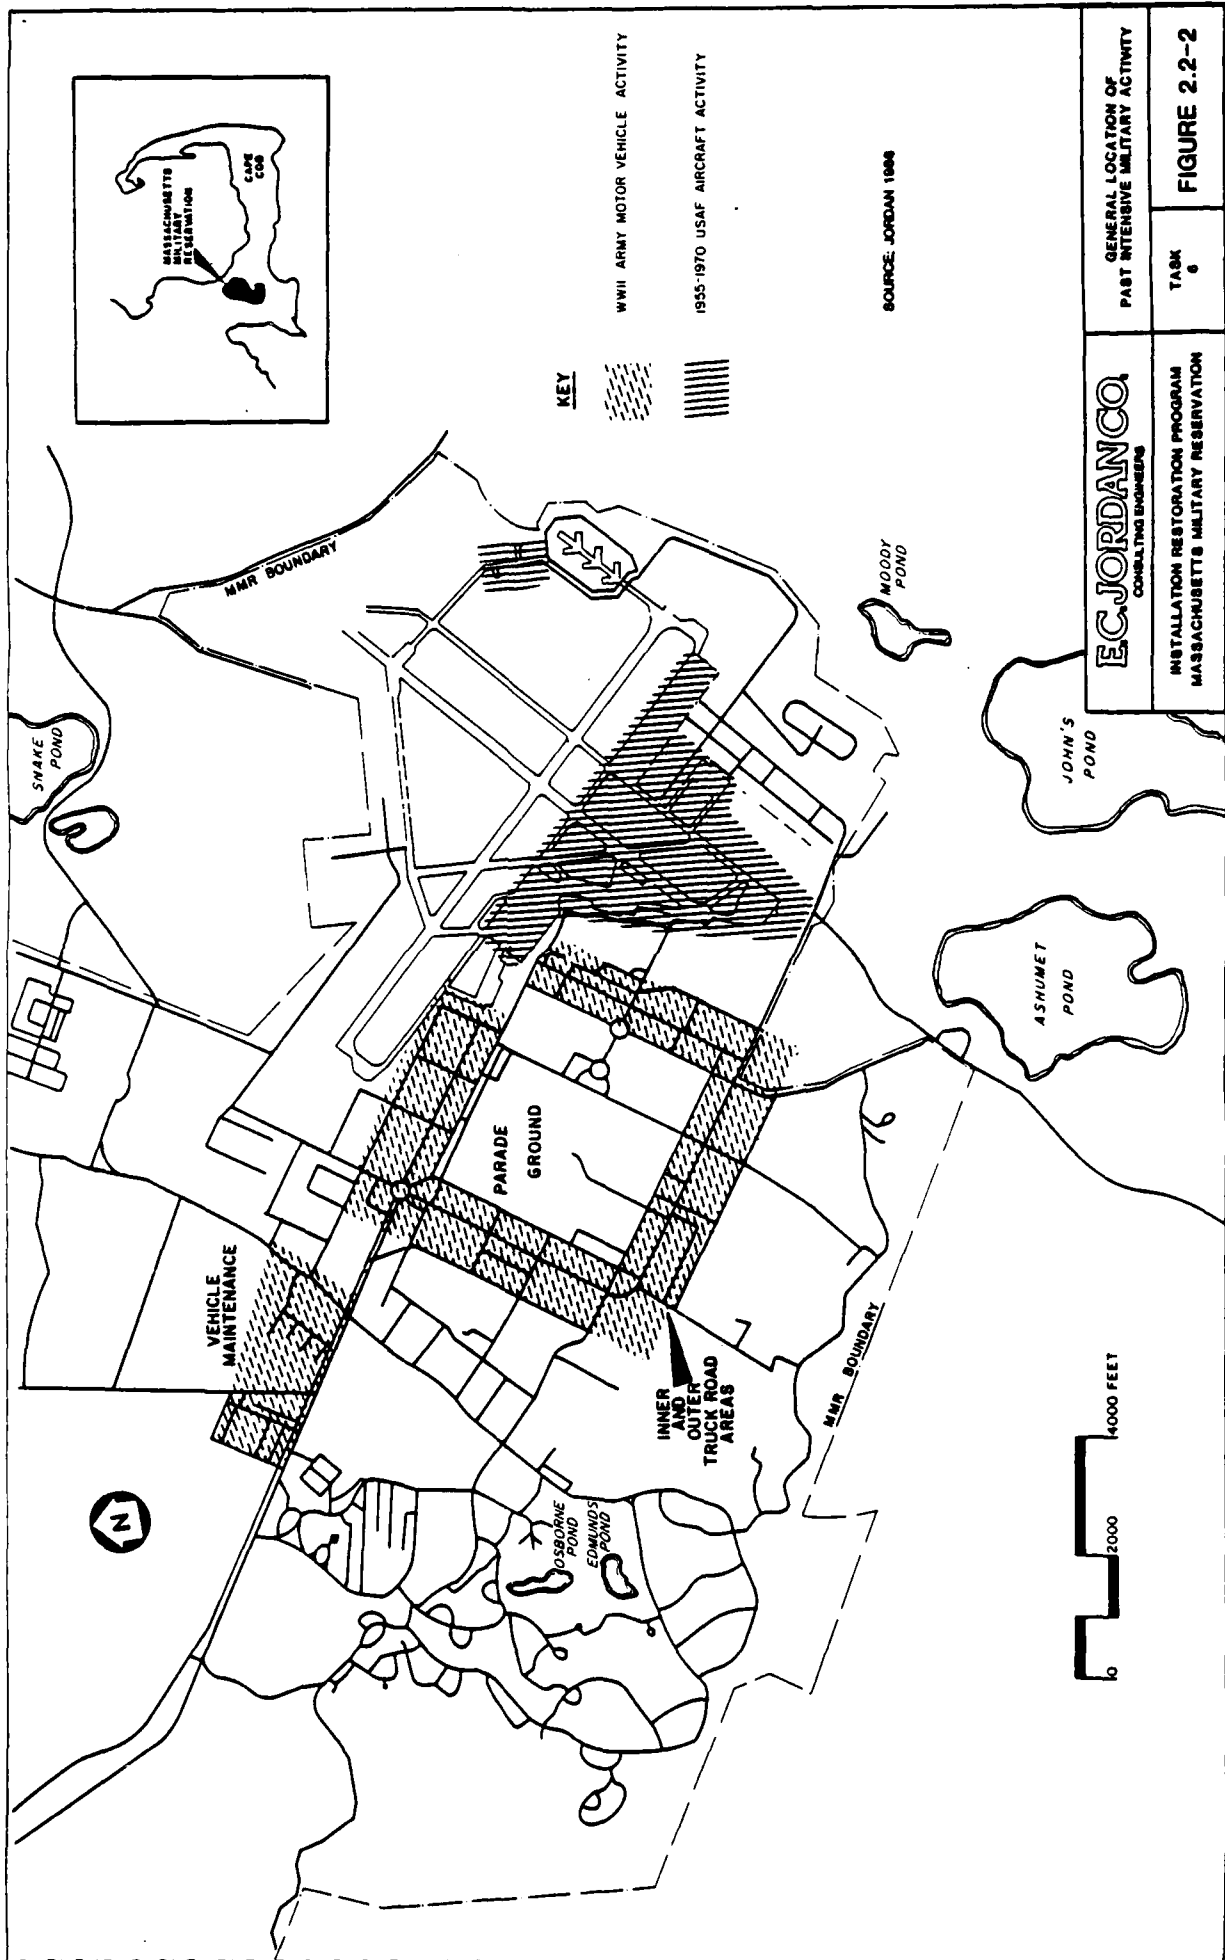
FIGURE 2.2-2

GENERAL LOCATION OF
PAST INTENSIVE MILITARY ACTIVITY

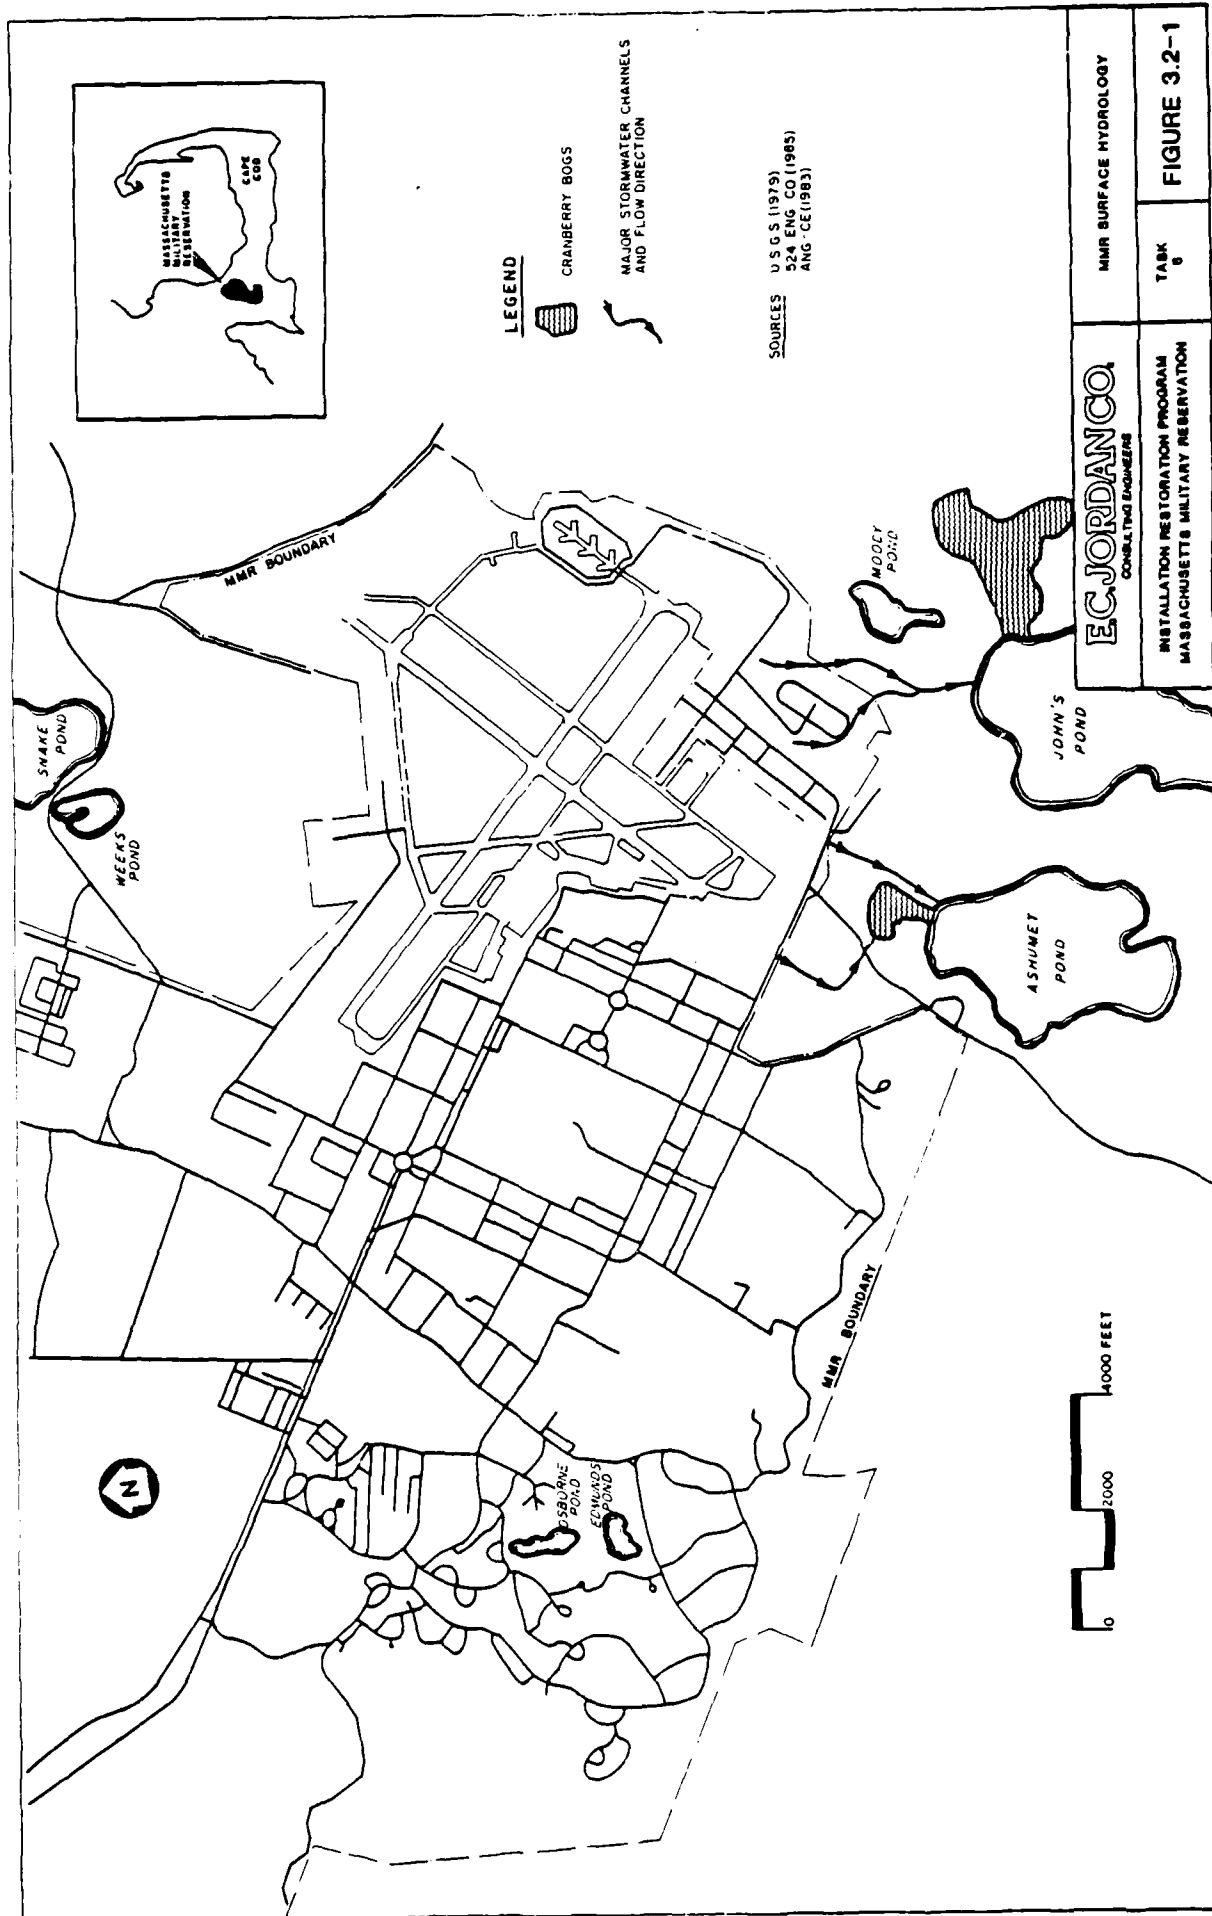
EC JORDANCO CONSULTING ENGINEERS		MMR SURFACE HYDROLOGY
INSTALLATION RESTORATION PROGRAM MASSACHUSETTS MILITARY RESERVATION	TASK 6	FIGURE 3.2-1

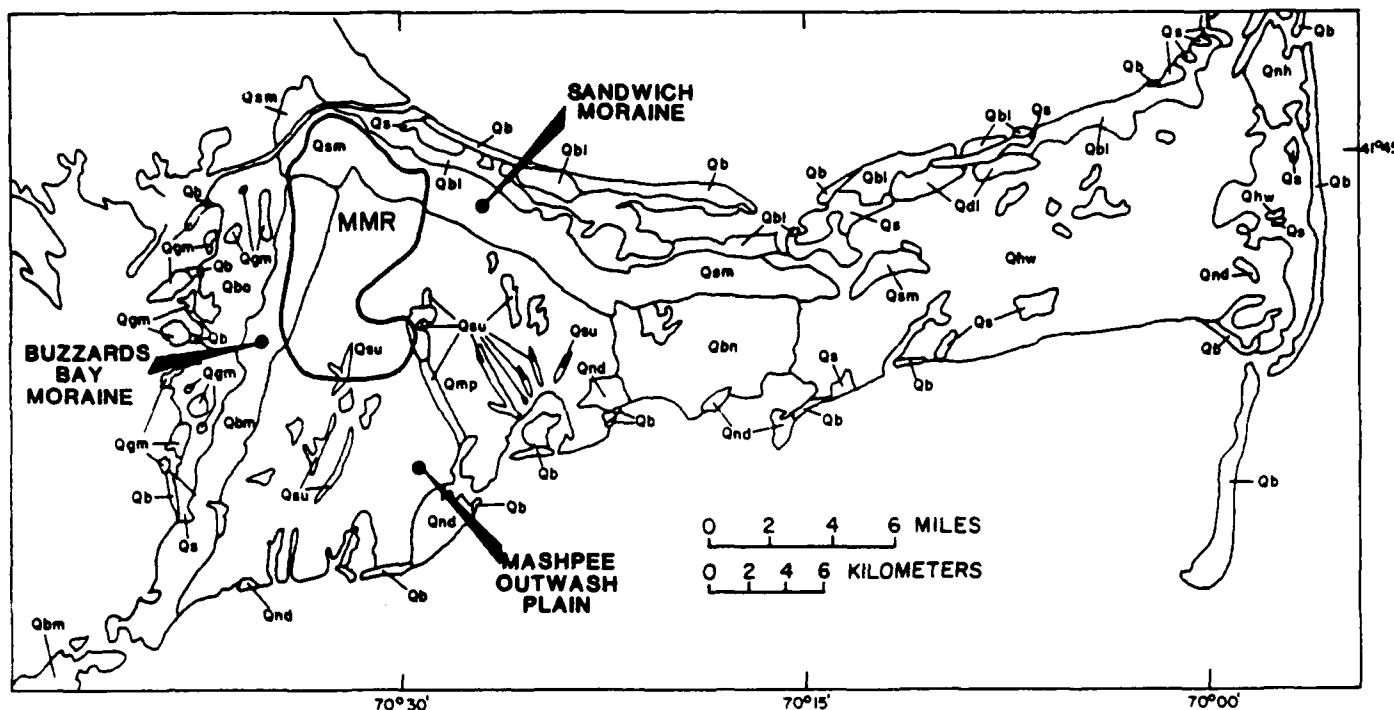
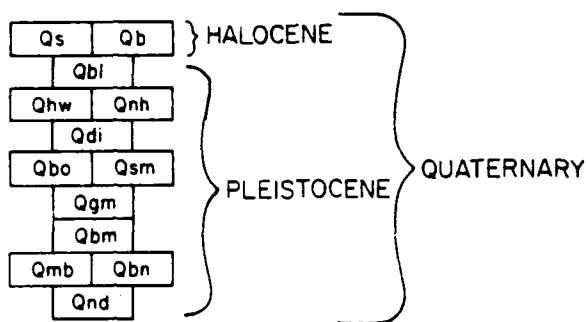
FIGURE 3.3-1

The MMR is characterized by three distinct surficial geologic units. In the northern section of the MMR, the east-west trending Sandwich Moraine (Qsm) is present. In the western section, the dominant geologic feature is the north-south trending Buzzards Bay Moraine (Qbm). These two recessional moraines intersect in the northwest corner of the MMR. To the south and east of the moraines, underlying the cantonment area, is the Masphee Outwash Plain (Qmp). Figure 3.3-1 shows the general locations of these features at MMR. As this figure shows, the cantonment and southeastern portion of the range and maneuver area are located on outwash deposits. The northern and western portions of the range and maneuver area and the VA Cemetery are on moraine formations.

The recessional moraines are an ice contact deposit, formed from boulders, gravel, sand, and silt sloughing off at the ice margin. At MMR it appears that the rate of advance of the ice sheet was matched by the rate of melting. As a result of the stationary ice margin, the moraines were allowed to develop. The moraines are characterized by a highly variable composition. The soils range from silty till to stratified sand and gravel (Oldale, 1976).

The outwash plain deposit was formed as a result of meltwater carrying sand, silt, and gravel away from the ice margin. These fluvial deposits are characterized by a uniformly graded, unconsolidated, stratified sand and gravel with traces of silt. Recent geologic data indicate the presence of lenses of silt

Qb	BEACH and DUNE DEPOSITS
Qs	SWAMP and MARSH DEPOSITS
Qbl	BARNSTABLE LAKE DEPOSITS
Qnh	NAUSET HEIGHTS ICE-CONTACT DEPOSITS
Qhw	HARWICH OUTWASH PLAIN DEPOSITS
Qdi	DENNIS ICE-CONTACT DEPOSITS
Qsm	SANDWICH MORaine DEPOSITS
Qbo	BUZZARDS BAY OUTWASH DEPOSITS
Qgm	BUZZARDS BAY GROUND MORaine DEPOSITS
Qbm	BUZZARDS BAY MORaine DEPOSITS
Qbn	BARNSTABLE OUTWASH PLAIN DEPOSITS
Qmp	MASHPÉE PITTED PLAIN DEPOSITS
Qbm	NANTUCKET SOUND ICE-CONTACT DEPOSITS
Qsu	SAND & GRAVEL UNDIFFERENTIATED

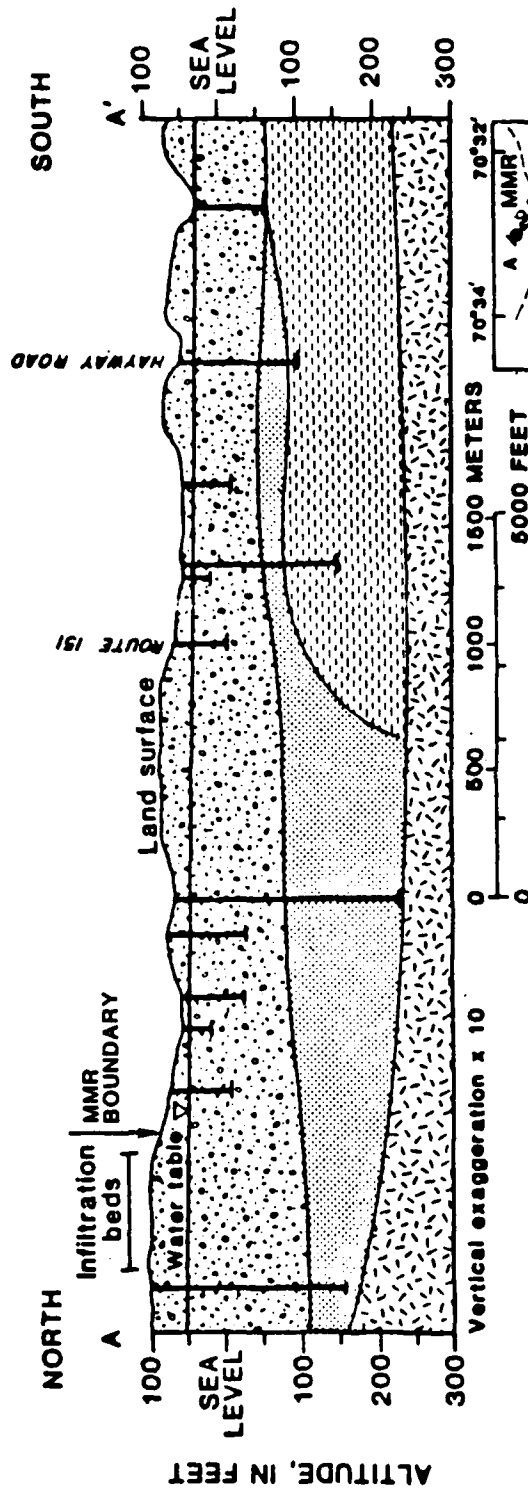
FIGURE 3.3-2

Cape Cod consists of unconsolidated glacial deposits. These deposits constitute an aquifer that serves as the primary source of water for the residents of Cape Cod. According to the U.S. EPA, this aquifer has been designated as a "sole source aquifer." The aquifer is bounded laterally by the Atlantic Ocean, Cape Cod Bay, Cape Cod Canal, and Nantucket Sound. The upper zones of the aquifer beneath the cantonment area are comprised of unconsolidated sand and

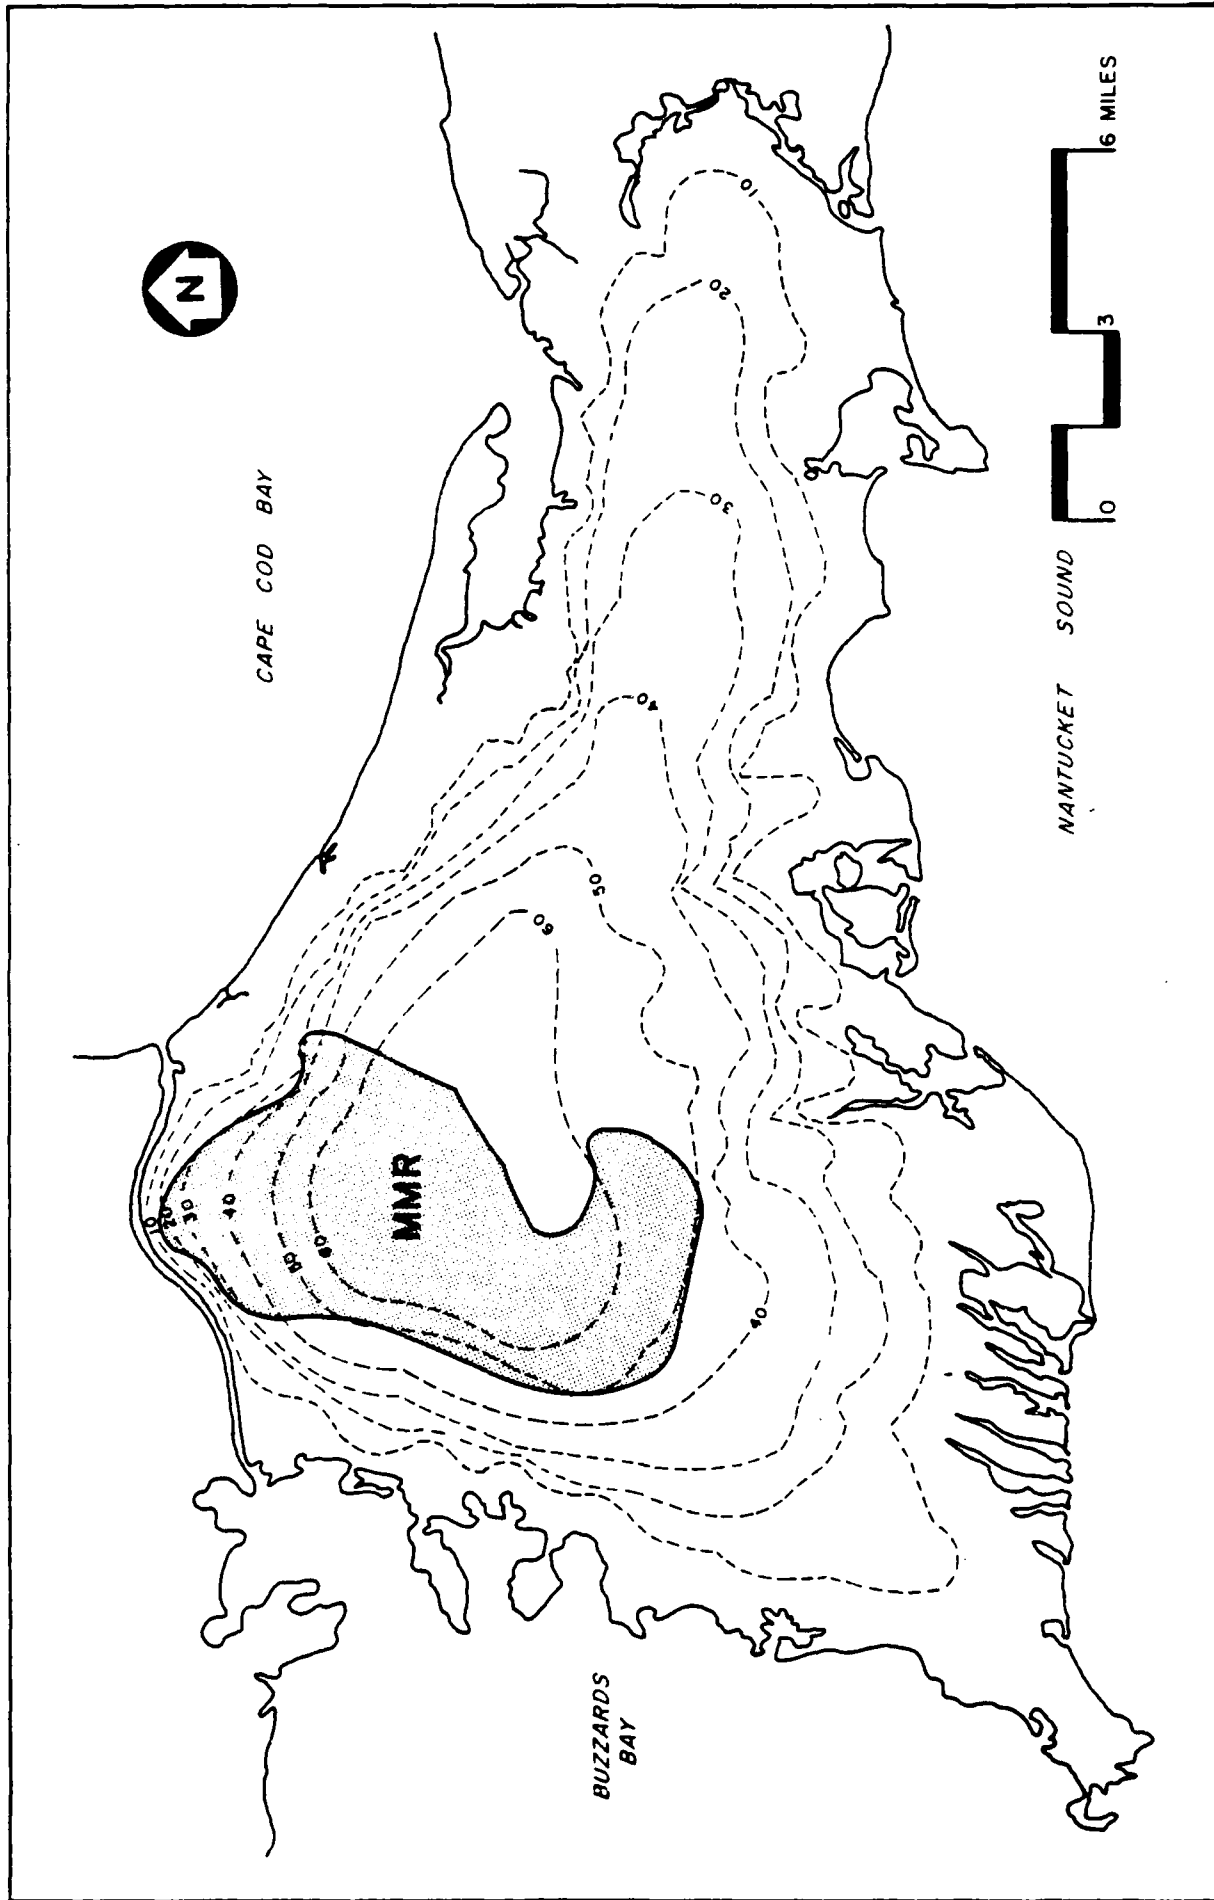
FIGURE 3.3.4

--10 -- OBSERVED AVERAGE WATER-TABLE CONTOUR, IN FEET,
DATUM IS SEA LEVEL, CONTOUR INTERVAL 10 FEET.

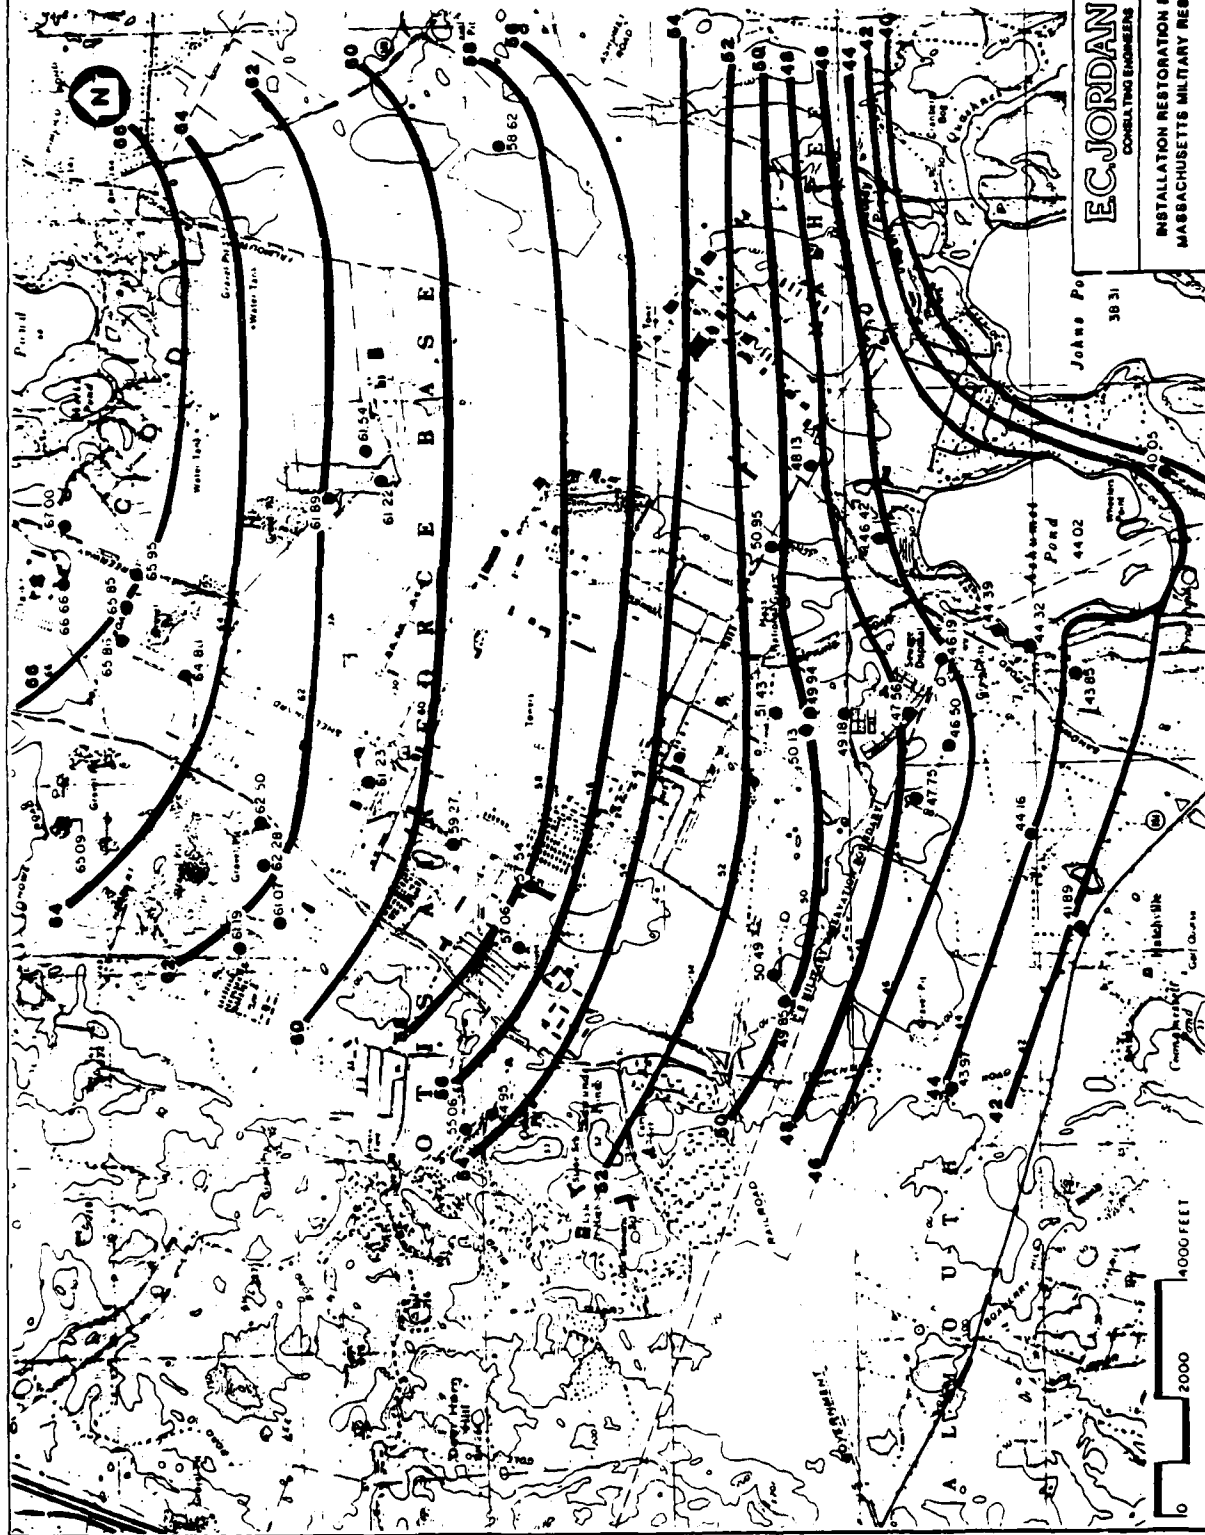
EC. JORDAN CO. CONSULTING ENGINEERS		MMR WATER SUPPLY WELL LOCATIONS	
INSTALLATION RESTORATION PROGRAM MASSACHUSETTS MILITARY RESERVATION		TASK 6	FIGURE 3.3-

wells (Wells B, E, G, and J) and pumping stations. Of the four original wells, only one (Well J) is presently in use. In addition to these wells, there are water supply wells located at the Coast Guard Transmitter Station, Cape Cod AFS, AVCO, and the VA Cemetery. All of the water supply wells are situated in the unconsolidated sand and gravel unit that contains the aquifer. The location of these wells is shown in Figure 3.3-6. Characteristics of the wells are summarized in Table 3.3-2. The wells range in depth from 40 to 412 ft below ground surface. Water demand at MMR is seasonal with peak demand from June through August when the highest level of training exercises occur. As stated previously, Well J is the only water supply well producing water for the cantonment area. Its maximum capacity is 1,350 gpm. The drawdown to the well at this capacity is approximately 5.7 ft. The capture zone for this well extends 1,000 ft to the east and west of the well, and the zone of influence has been estimated to extend out 1,000 ft in radius from the well location. Some of the water supply wells have been closed due to contamination. The contamination status of the water supply wells is discussed in Section 3.4.2.

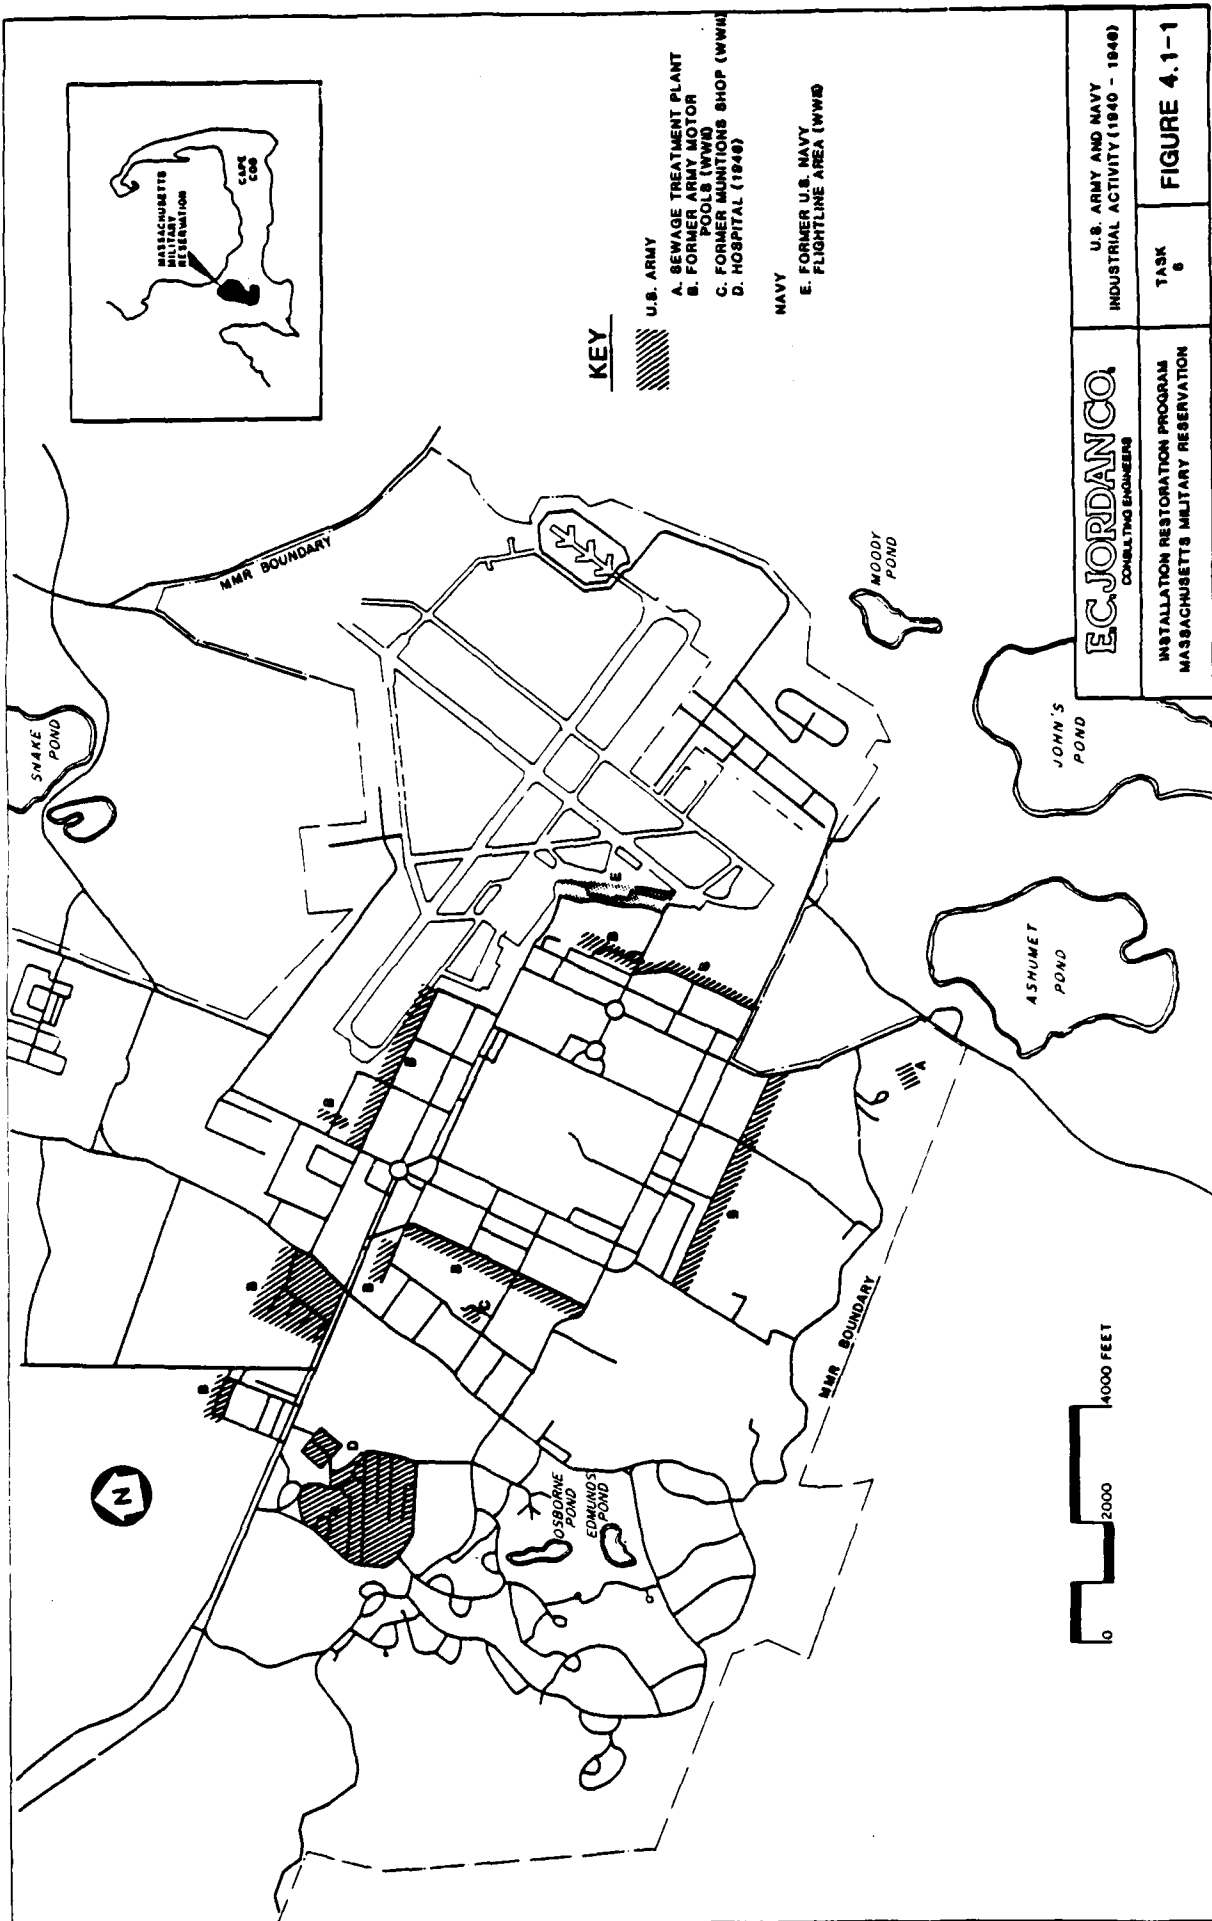
FIGURE 4.1-1

U.S. ARMY AND NAVY
INDUSTRIAL ACTIVITY (1940 - 1948)
